PROJECT: Itasca Community College
Media Center Area (I3)

DATE: May 3, 2016

FILE NO.: 16-9779-07-ICC

UPDATE PRE-DESIGN REPORT

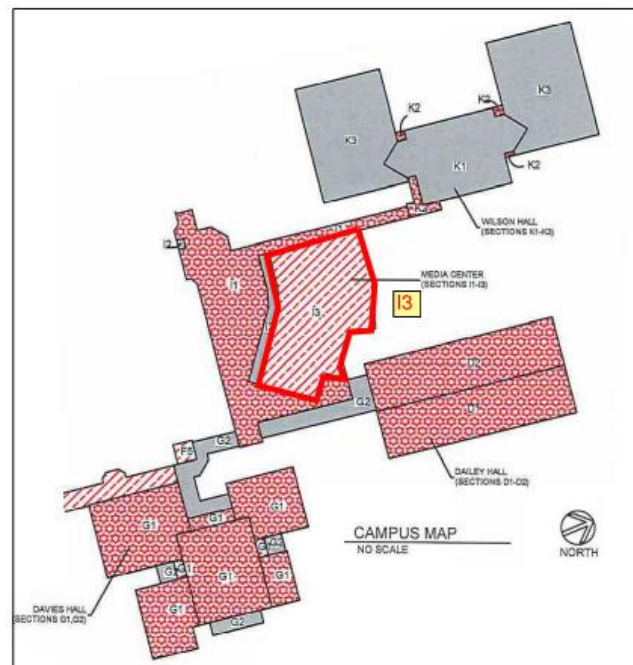
I3-Media Center Roof

The subject roof consists of a sloped compact roof system covered with shingles. The roof is at the end of its service life and requires immediate replacement.

Moisture has infiltrated through the shingles and saturated the plywood sheathing. This moisture infiltration has saturated the roof insulation, damaged interior finishes, windows and caused distress to the north exterior wall.

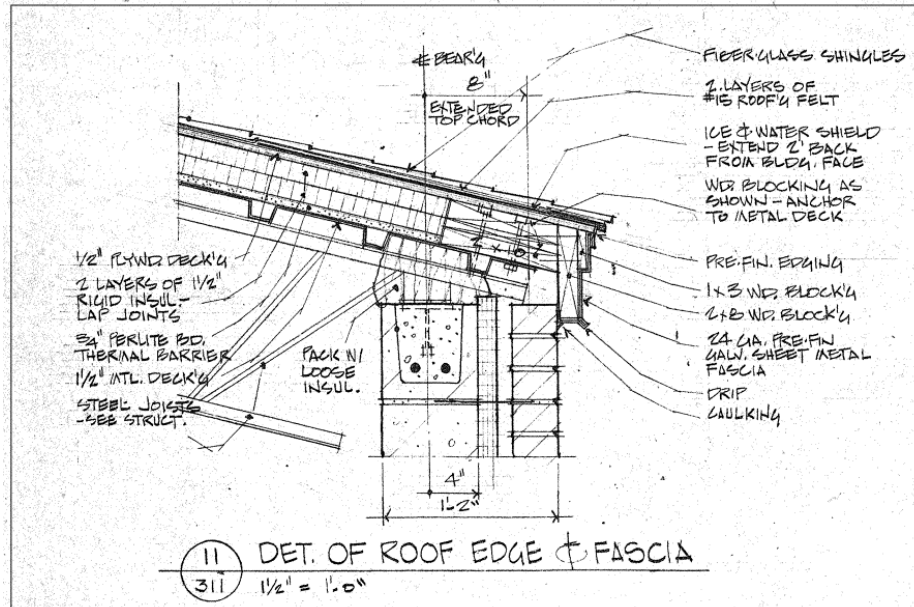
Excerpt from original drawings

1. The existing roof framing is structurally sloped, approximately 3” per foot. The roof is considered a compact (non-vented) shingle roof.

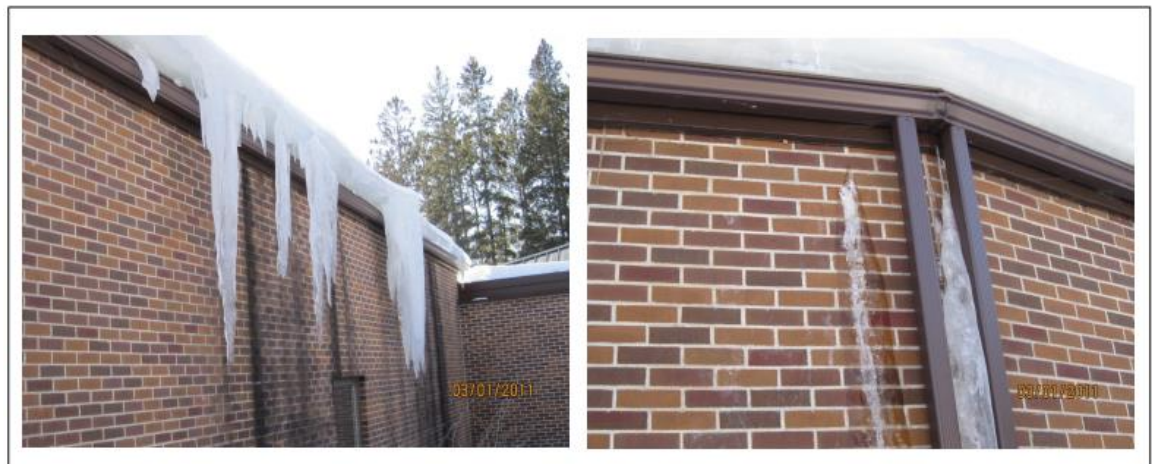
Extensive ice damming occurs during the winter months. The ice damming has resulted in moisture infiltration into the roof system, interior, and within the exterior masonry cavity walls. Moreover, the moisture infiltration has saturated the roof insulation, deteriorated the wood sheathing and created masonry staining and masonry distress below the subject roof.

2. A roof system other than the typical MnSCU built-up roof system will be required due to the slope of the roof.
 - a. The existing shingles, underlayment, roof sheathing/blocking and insulation should be removed down to the existing sloped metal roof deck.

- b. Metal deck repair/replacement is expected near the eave.
 - c. New mechanically fastened thermal barrier, roof vapor retarder, insulation and sheathing shall be installed.

- d. The amount/thickness of insulation will require to be increased to meet building code and to mitigate ice damming. In addition, various venting design strategies (possibly venting above the insulation) should also be reviewed during the design phase to further mitigate the ice damming.

- e. The preferred roof system is a metal standing seam roof similar to other roof on campus.
3. Due to the increase in roof insulation, regardless of the type of roof covering, the new roof will be heavier than the existing roof system. Therefore, a structural evaluation will need to be completed for the proposed roof system. (It should be noted that existing structural drawings were not available at the time of this pre-design report. Therefore, we assume that field verification of structural capacity of the roof will be required.)

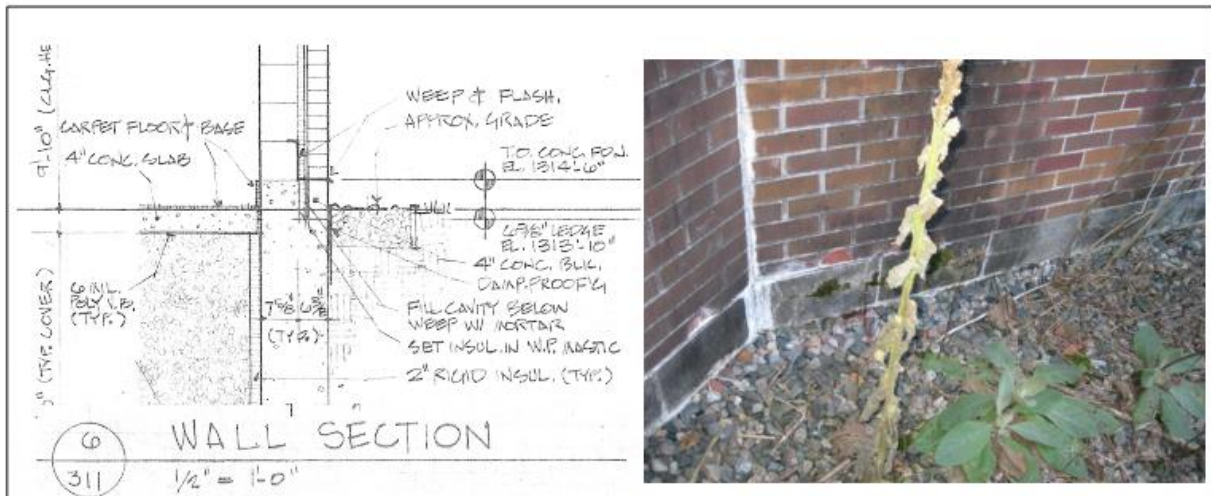
1. According to the existing document, the base of wall flashing is located approximately 6-inches above grade. Concrete masonry units (CMU) were used in lieu of face brick at the brick shelf just below the through-wall flashing. The CMU and surrounding masonry is showing signs of distress.
 - a. New waterproofing, through wall flashing and associated masonry replacement shall be included.
 - b. The elevation of the new through wall flashing shall be coordinated with the alternations at grade.

2. Various masonry repairs to this wall should also be considered to include: tuck-pointing, spot brick replacement, sealant joint replacement and masonry cleaning.
3. The existing windows on the related north wall are 25+ years old and at the end of their service life. These window, sill and flashings are also showing signs of distress due to the moisture infiltration. We recommend the windows, sills and flashing be replaced as part of the wall work.

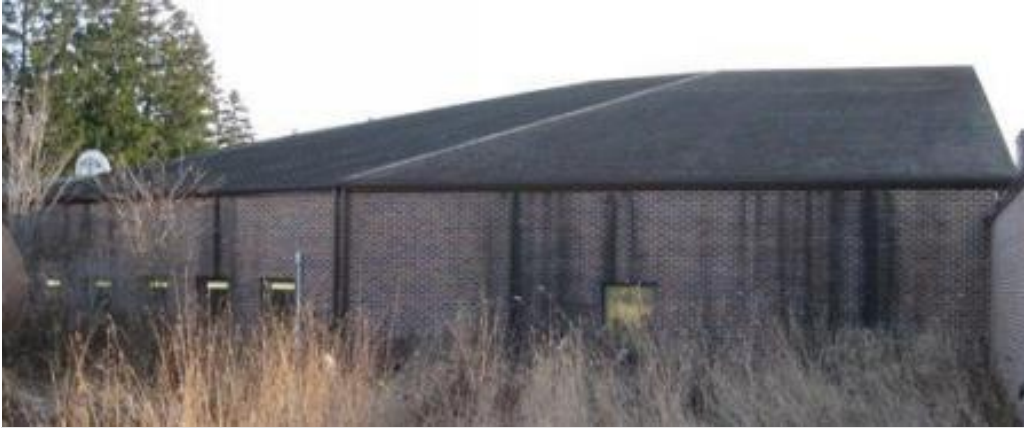
Photo #1: Overview of Roof Area I3 and subject wall.

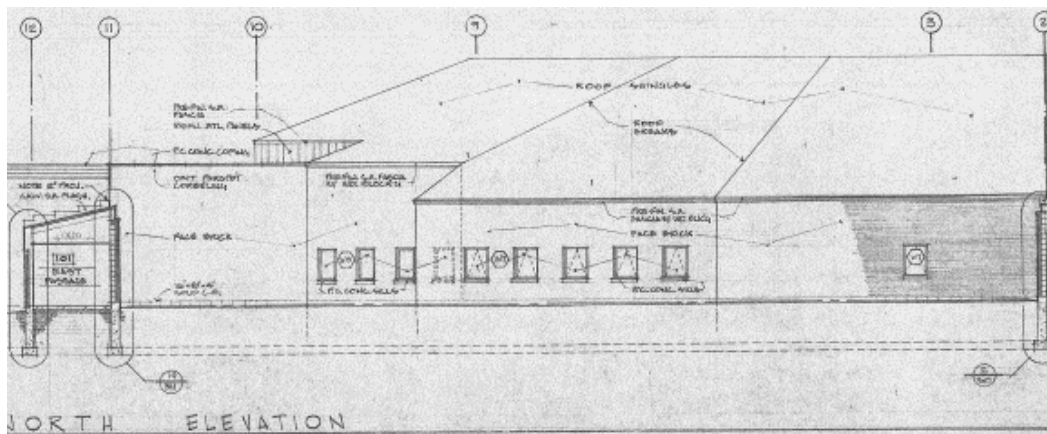
Photo #2: Partial elevation of north elevation showing subject roof and wall.

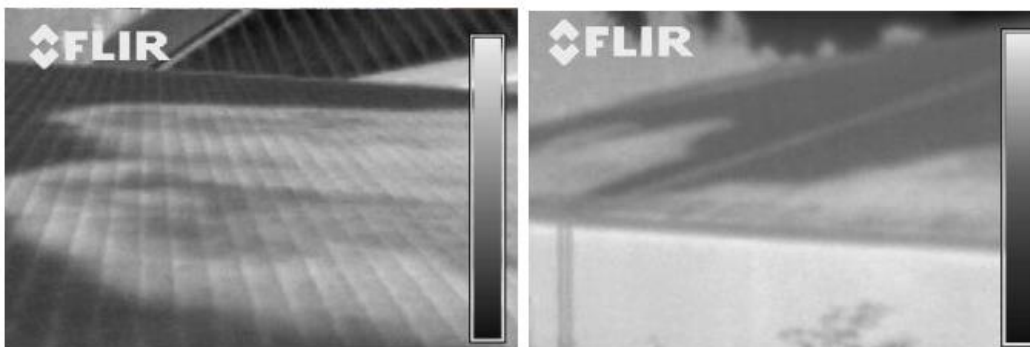
Photo #3: View of IR of compact shingle roof.

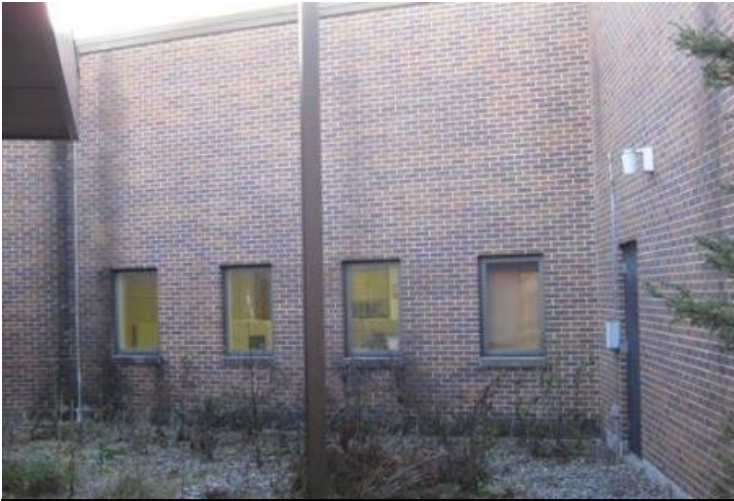
Photo #4: Overview of north elevation and windows.

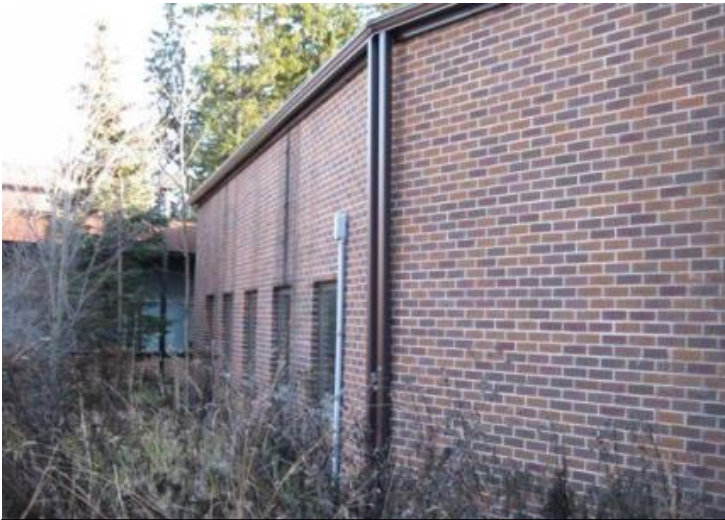
Photo #5: Overview of north elevation.

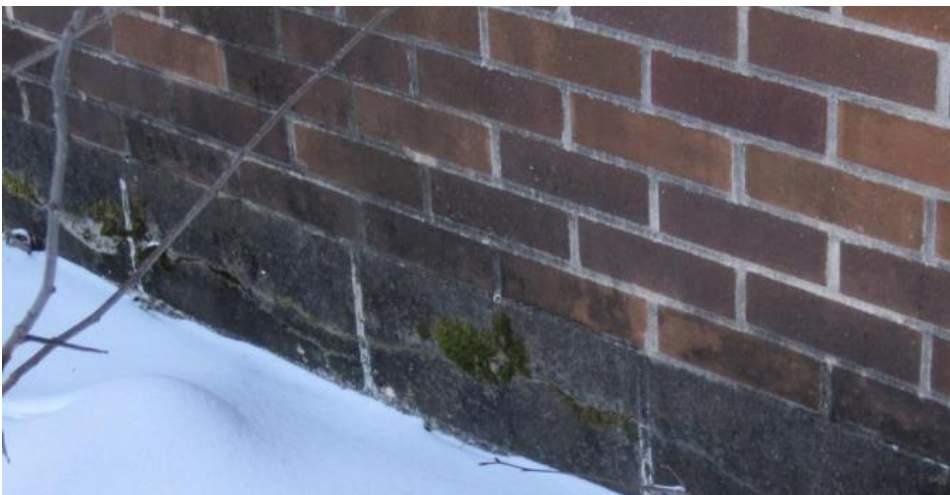
Photo #6: Enlarged view of damaged CMU at base of building.
